## **Exterior Renovation Update 05-27-22**

The exterior renovation is moving apace. Demolition is about 75% complete—stone, siding, and roofing. New waterproofing has been installed where the roof has been torn off to keep things dry. They have started on the installation on the windows.

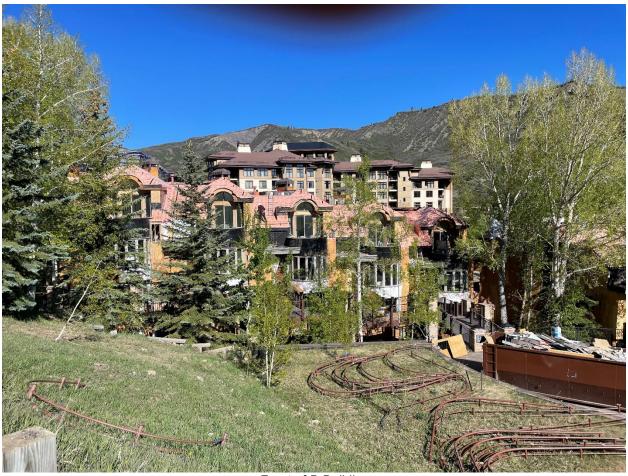
Front of B Building

The first two photographs show broad views of the front and the back of B and A building respectively. The railings appearing in the foreground of the first will eventually be taken away to be painted and then re-installed toward the end of the project.

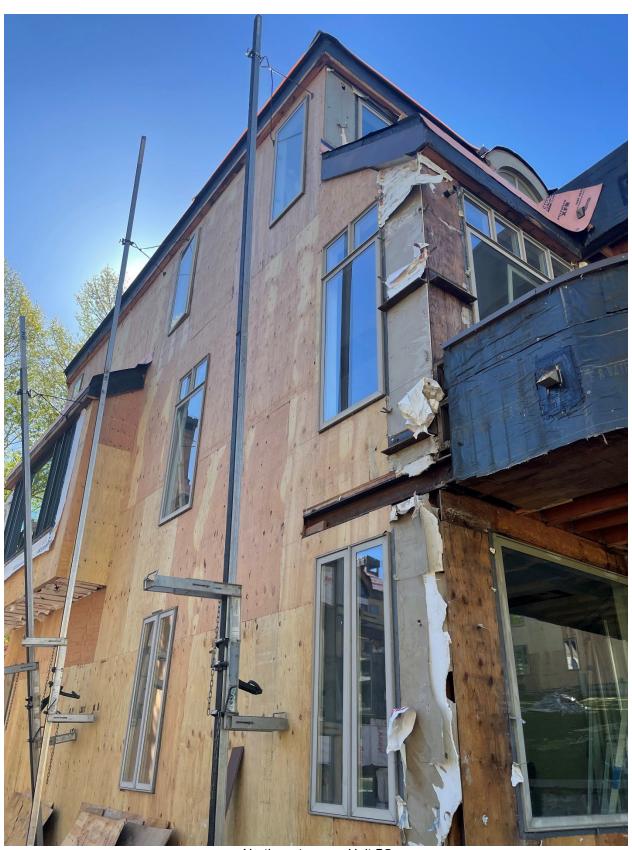
Northwest corner Unit B5

During demolition of the stone veneer and wood siding, workers discovered that the building sheathing was almost entirely gypsum board—aka drywall or Sheetrock™—rather than plywood. The vast majority of the gypsum board was rotten and was replaced with ½ plywood to provide the proper backing for the stone and siding.

The original *scope of work* included removal of only a small portion of the existing stone veneer and the addition of some on the front and the northwest corners of the buildings. Because of the rotten gypsum board, all the stone needed to be removed. You can see in the below picture some of the drywall still on the northwest corner of the building—on the north side right of the living room and guest master windows, and on the west side to the left of the master bedroom window. The plywood on the north side is all new, the plywood on the west side is original, one of the few places that actually had plywood. It is discolored due to age and not due to damage; it is still structurally sound. You can also see the new dining room window! The second picture below is the south side of A1 and shows new plywood everywhere except for the decks.
